Stellaris[®] LM3S5B91 RevB1 Errata

This document contains known errata at the time of publication for the Stellaris[®] LM3S5B91 microcontroller. The table below summarizes the errata and lists the affected revisions. See the data sheet for more details.

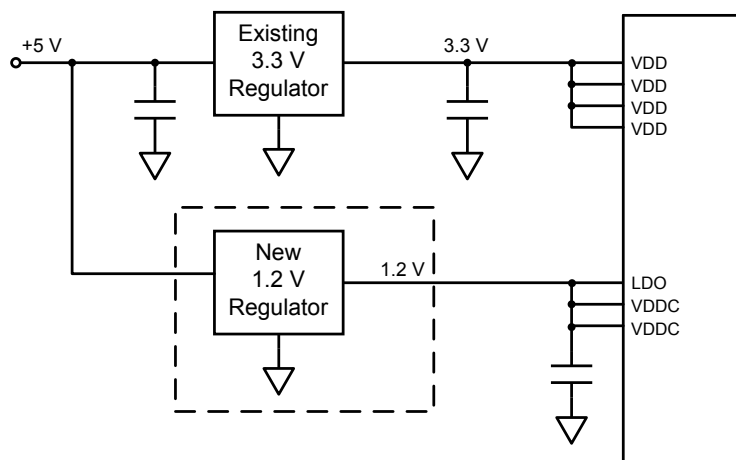
Figure 1. Configuration of External Regulator

12.1 Power-on event may disrupt operation

Incorrect power sequencing during power up can disrupt operation and potentially cause device failure.

V_{DDC} must be applied approximately 50 μ s before V_{DD} . Normally V_{DDC} is controlled by the part's internal LDO voltage regulator. The workaround requires the addition of an external regulator (see Figure 1) to ensure that V_{DDC} sequencing requirements are met (see Figure 2). Recommended regulators include FAN1112SX (SOT223) and FAN2558S12X (SOT23-5).

This fix mitigates the on-chip power issue, but does not solve it completely. During development, the Flash memory should also be reprogrammed (using LMflash or another programming tool) at least once a week.
