## Stellaris<sup>®</sup> LM3S9B92 RevB1 Errata

This document contains known errata at the time of publication for the Stellaris<sup>®</sup> LM3S9B92 microcontroller. The table below summarizes the errata and lists the affected revisions. See the data sheet for more details.

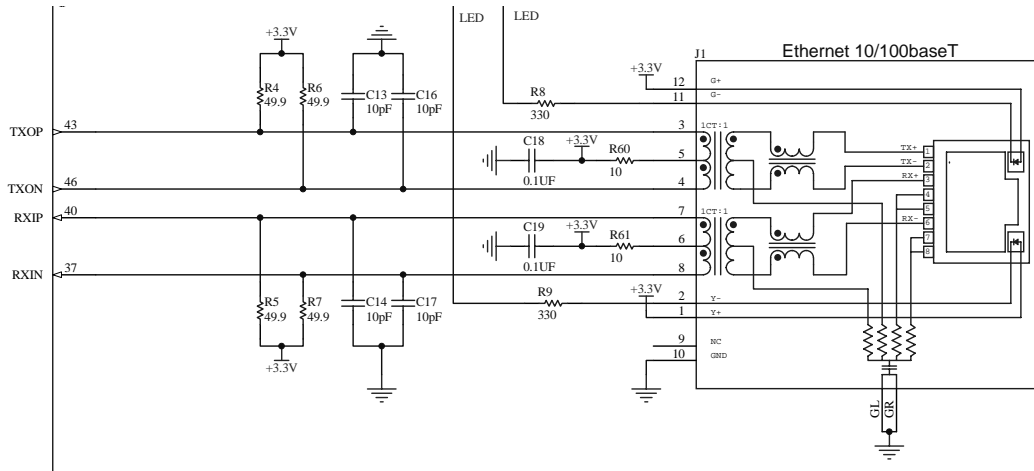
Figure 1. Recommended Center-Tap Connections

The microcontroller experiences some packet loss with Ethernet cables longer than 50 meters in normal operating conditions.

1. Add 10  $\Omega$  resistor to the center-tap of the transformer as shown in the figure. These resistors should be replaced by a direct connection for silicon that has this item fixed.
2. Continue using the recommended circuit, but limit cable lengths to 50 meters.

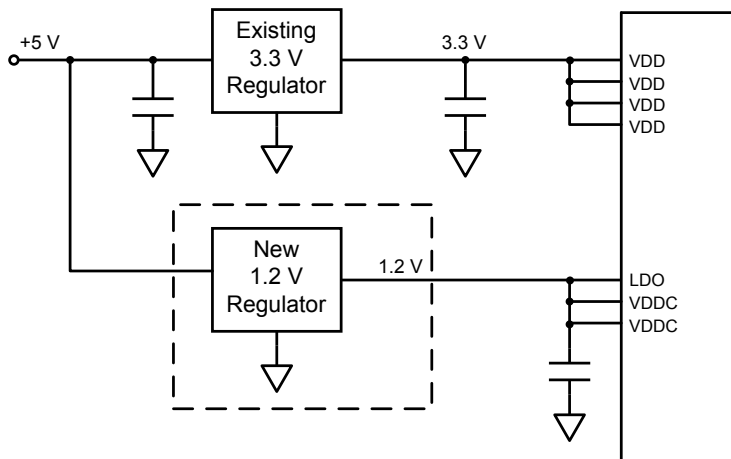
Figure 2. Configuration of External Regulator

Incorrect power sequencing during power up can disrupt operation and potentially cause device failure.

$V_{DDC}$  must be applied approximately 50  $\mu$ s before  $V_{DD}$ . Normally  $V_{DDC}$  is controlled by the part's internal LDO voltage regulator. The workaround requires the addition of an external regulator (see Figure 2) to ensure that  $V_{DDC}$  sequencing requirements are met (see Figure 3). Recommended regulators include FAN1112SX (SOT223) and FAN2558S12X (SOT23-5).

This fix mitigates the on-chip power issue, but does not solve it completely. During development, the Flash memory should also be reprogrammed (using LMflash or another programming tool) at least once a week.
