## PIC32MX534/564/664/764 Family Silicon Errata and Data Sheet Clarification

The PIC32MX534/564/664/764 family devices that you have received conform functionally to the current Device Data Sheet (DS61156G), except for the anomalies described in this document.

**Note:** This document summarizes all silicon errata issues from all revisions of silicon, previous as well as current. Only the issues indicated in the last column of [Table 2](#) apply to the current silicon revision (**A1**).

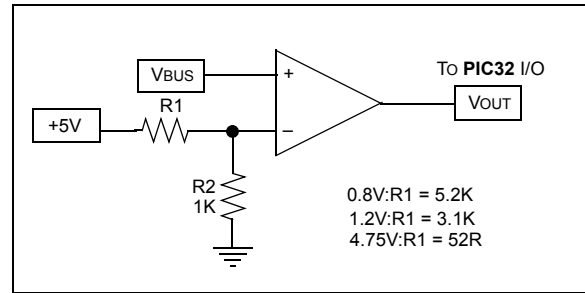
FIGURE 1: EXTERNAL COMPARATOR SCHEMATIC EXAMPLE

When the USB model is configured for OTG operation, it may not properly recognize all required OTG voltage levels on VBUS pin.

Use external comparator circuit to detect OTG specific voltage levels on VBUS pin.
