MSP430F13x/14x/14x1 Device Erratasheet

Current Version

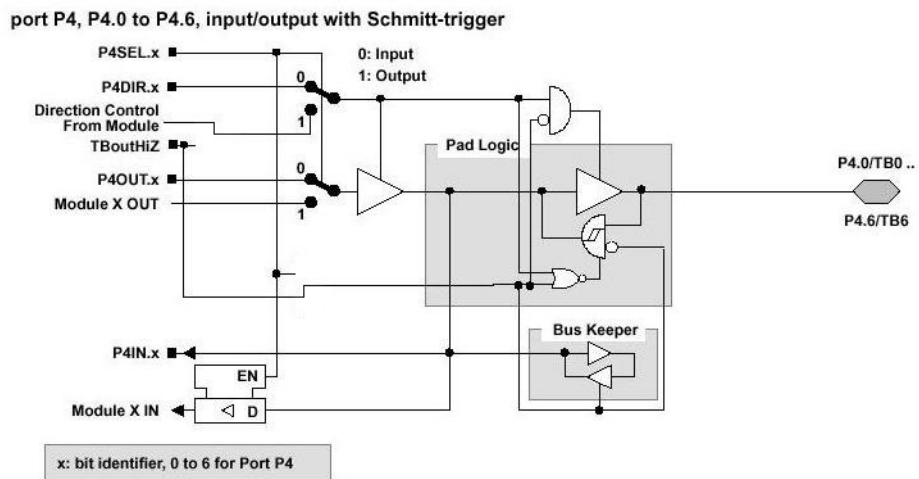
Port realization with TB3 bug:

TB3 TB3 - Bug description:

Module: Timer_B, Function: Port is switched to tristate independent of selected function

Incorrect tristate function of Ports P4.0/TB0 through P4.6/TB6 (TBoutHiZ control). If TBoutHiZ is set to high, all ports P4.0/TB0 through P4.6/TB6 are set to tristate, independent of the P4SEL.x control signals. This means a port P4.x is switched to tristate with TBoutHiZ, even if it is not selected for Timer_B function.

In addition, the ports P4.0/TB0 through P4.6/TB6 are switched to tristate with TBoutHiZ, even if the port direction (direction control from module) is set to input. This is in accordance with the specification description but, nevertheless, is an unexpected behavior.

No workaround.
