MSP430FG43x Device Erratasheet

Current Version

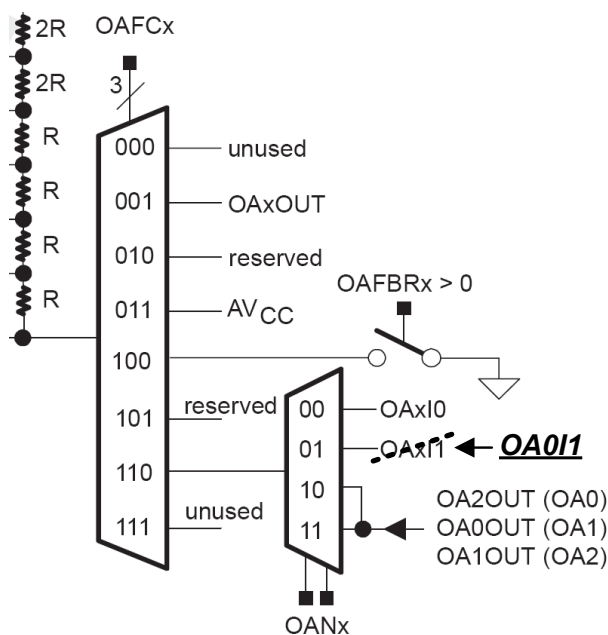
OA1 OA1 - Bug description:

Module: OA, Function: OAx11 input selection

Referring to the OA block diagram in the MSP430x4xx User's Guide, the internal connection of the OAx11 input to the OAFc mux is incorrect. The signal input to the OAFc mux when OANx = 01 is OA011 for all OAs. See the figure below for a graphical representation:

Workaround:

None
