## PIC18F2X1X/4X1X Rev. B3 Silicon Errata

The PIC18F2X1X/4X1X Rev. B3 parts you have received conform functionally to the Device Data Sheet (DS39636C), except for the anomalies described below. Any Data Sheet Clarification issues related to the PIC18F2X1X/4X1X will be reported in a separate Data Sheet errata. Please check the Microchip web site for any existing issues.

The following silicon errata apply only to PIC18F2X1X/4X1X devices with these Device/Revision IDs:

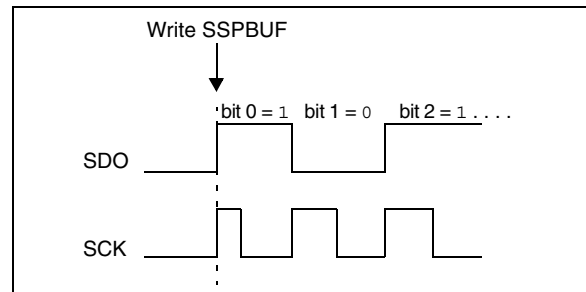
**FIGURE 1: SCK PULSE VARIATION USING TIMER2/2**

When the SPI is using Timer2/2 as the clock source, a shorter than expected SCK pulse may occur on the first bit of the transmitted/received data (Figure 1).

To avoid producing the short pulse, turn off Timer2 and clear the TMR2 register, load the SSPBUF with the data to transmit and then turn Timer2 back on. Refer to Example 1 for sample code.
