# MICROCHIP PIC18F2420/2520/4420/4520

## PIC18F2420/2520/4420/4520 Rev. B3 Silicon Errata

The PIC18F2420/2520/4420/4520 Rev. B3 parts you have received conform functionally to the Device Data Sheet (DS39631C), except for the anomalies described below. Any Data Sheet Clarification issues related to the PIC18F2420/2520/4420/4520 will be reported in a separate Data Sheet errata. Please check the Microchip web site for any existing issues.

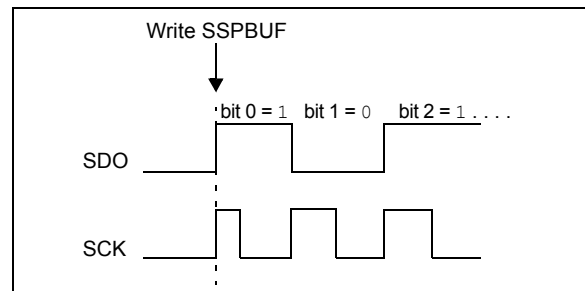
FIGURE 1: SCK PULSE VARIATION USING TIMER2/2

When the SPI is using Timer2/2 as the clock source, a shorter than expected SCK pulse may occur on the first bit of the transmitted/received data (Figure 1).

To avoid producing the short pulse, turn off Timer2 and clear the TMR2 register, load the SSPBUF with the data to transmit and then turn Timer2 back on. Refer to Example 1 for sample code.
