PIC18F2525/2620/4525/4620

PIC18F2525/2620/4525/4620 Rev. A3 Silicon Errata

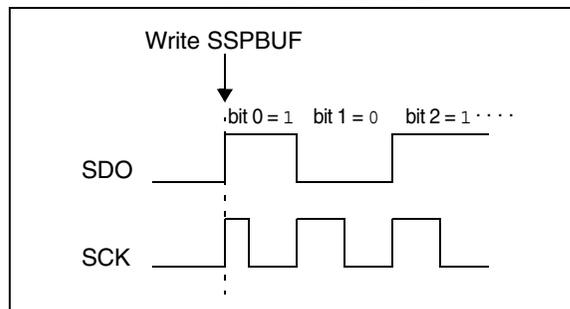
FIGURE 1: SCK PULSE VARIATION USING TIMER2/2

When the SPI is using Timer2/2 as the clock source, a shorter than expected SCK pulse may occur on the first bit of the transmitted/received data (Figure 1).

To avoid producing the short pulse, turn off Timer2 and clear the TMR2 register, load the SSPBUF with the data to transmit and then turn Timer2 back on. Refer to Example 5 for sample code.
