# MICROCHIP PIC18F2525/2620/4525/4620

## PIC18F2525/2620/4525/4620 Rev. A4 Silicon Errata

The PIC18F2525/2620/4525/4620 Rev. A4 parts you have received conform functionally to the Device Data Sheet (DS39626D), except for the anomalies described below. Any Data Sheet Clarification issues related to the PIC18F2525/2620/4525/4620 will be reported in a separate Data Sheet errata. Please check the Microchip web site for any existing issues.

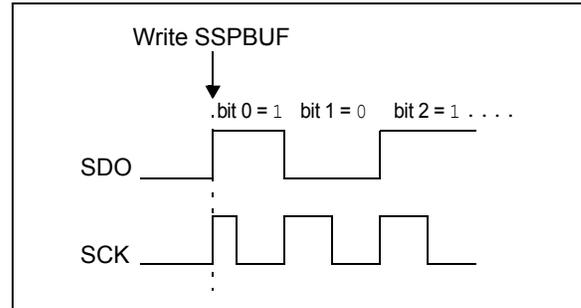
**FIGURE 1: SCK PULSE VARIATION USING TIMER2/2**

When the SPI is using Timer2/2 as the clock source, a shorter than expected SCK pulse may occur on the first bit of the transmitted/received data (Figure 1).

### Work around

To avoid producing the short pulse, turn off Timer2 and clear the TMR2 register, load the SSPBUF with the data to transmit and then turn Timer2 back on. Refer to Example 5 for sample code.
