PIC16CR63

PIC16CR63 Rev. A Silicon Errata Sheet

The PIC16CR63 parts you have received conform functionally to the Device Data Sheet (**DS30234D**), except for the anomalies described below.

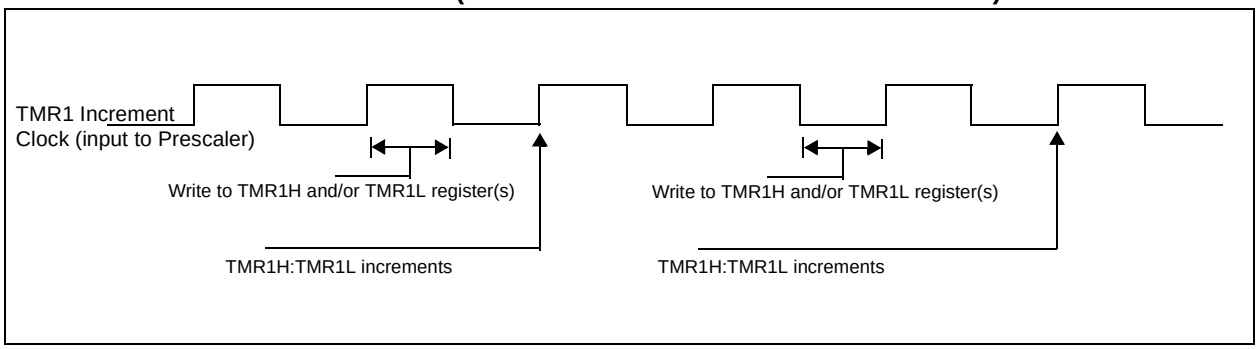
FIGURE 1: WRITES TO TIMER1 (EXTERNAL CLOCK / OSCILLATOR MODE)

a) The operation of Timer1 needs some clarification when the timer registers are written when the TMR1ON bit is set.

The internal clock signal that is the input to the TMR1 prescaler affects the incrementing of Timer1 (TMR1H:TMR1L registers and the Timer1 prescaler). When the Timer1 registers are NOT written, the Timer1 will increment on the rising edge of the TMR1 increment clock.

When the TMR1H and/or TMR1L registers are written while this clock is high, TMR1 will increment on the next rising edge of this clock.

When the TMR1H and/or TMR1L registers are written while this clock is low, TMR1 will not increment on the next rising edge of this clock, but must first have a falling clock and the the rising clock for TMR1 to increment.

Figure 1 shows the two cases of writes to the TMR1H and/or TMR1L registers. Due to the VIH and VIL thresholds on the oscillator/clock pins, external Timer1 oscillator components, and external clock frequency, the Timer1 increment clock may not be of a 50% duty cycle.

The TMR1 increment clock is out of phase of the T1OSO/T1CKI pin by a small propagation delay.
